POST. Lab.
WATERTOWN ARSENAL
WATERTOWN, MASS.

REPORT NO. 710/197

A STUDY OF
THE MECHANISM OF PENETRATION OF HOMOGENEOUS
ARMOR PLATE

E. L. REED
Research Metallurgist

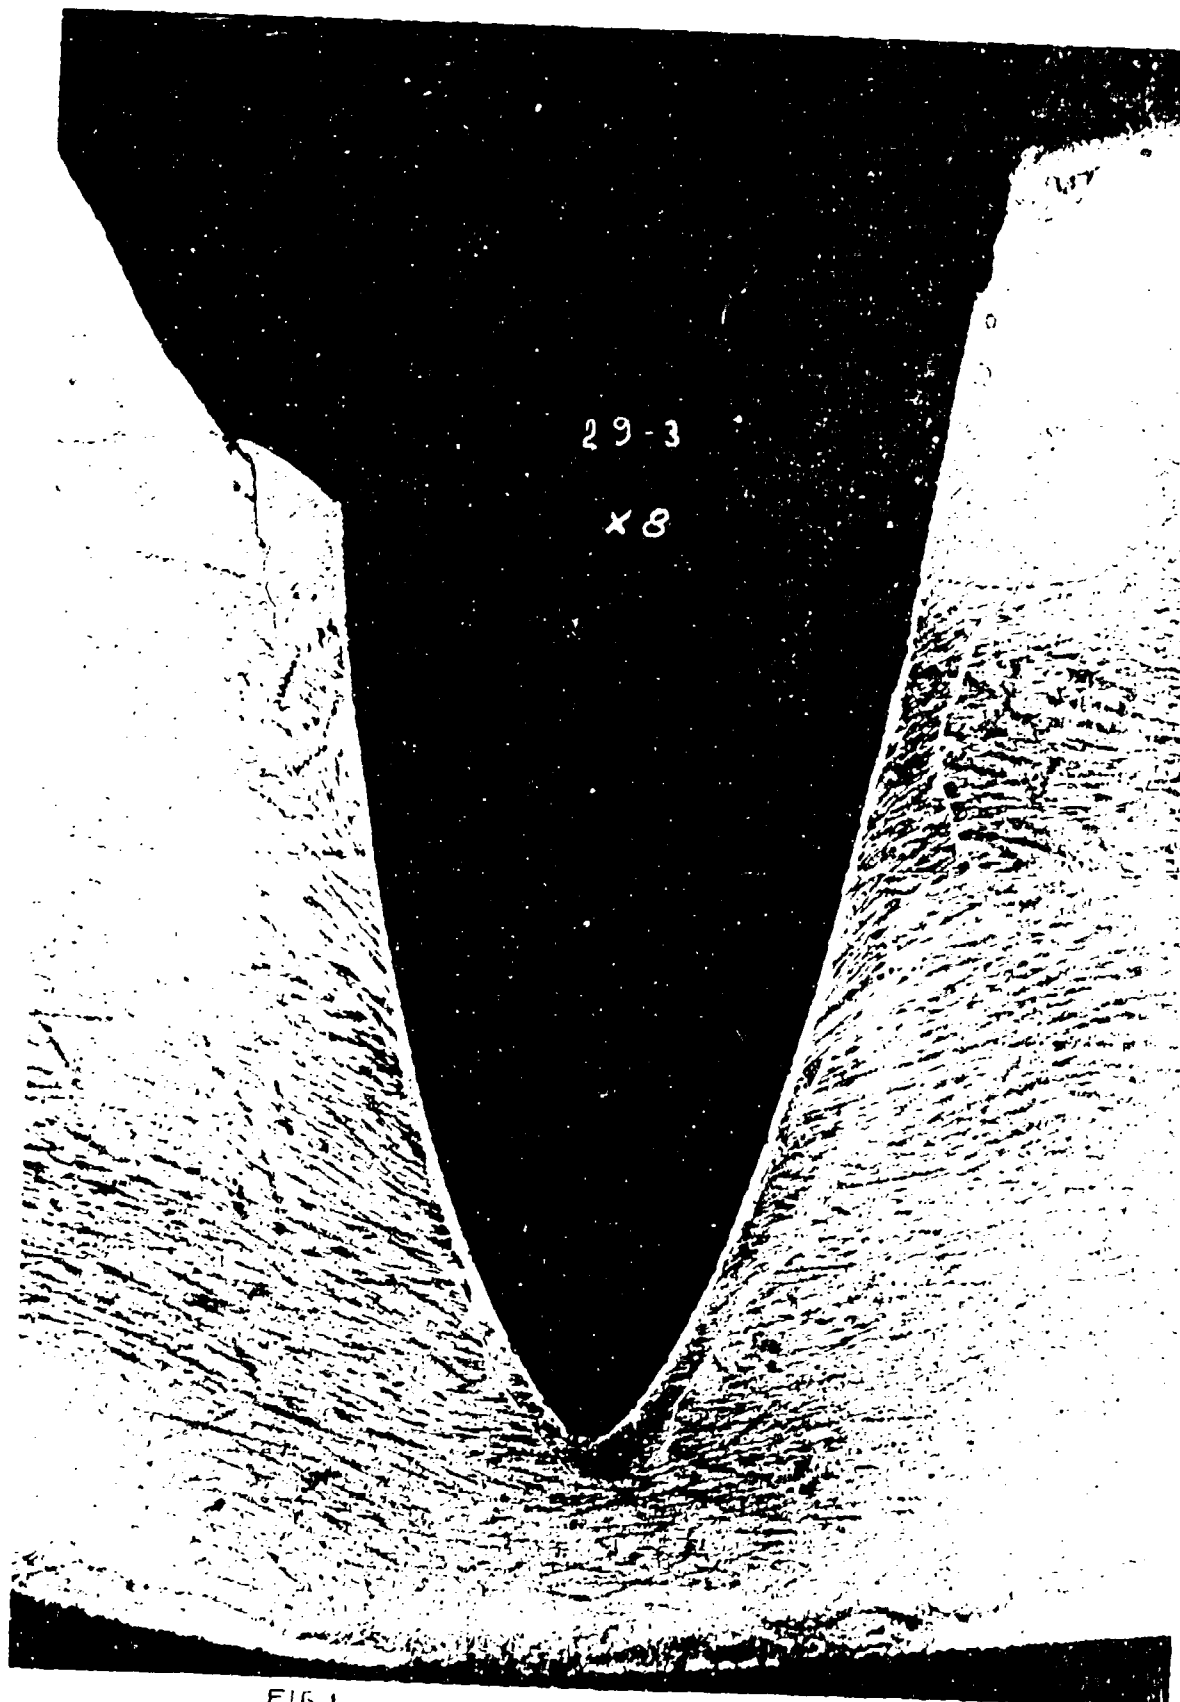
FIG 1

Macrostructure of partial penetration
of .50 Caliber A.P. bullet into high ballis-
tic plate shows deformation of banding and
"white layer".

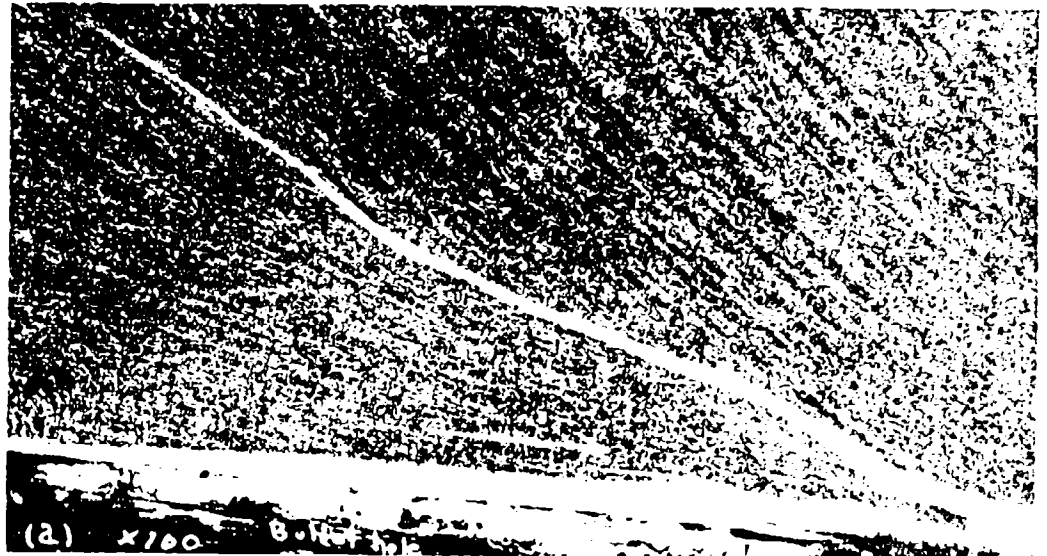
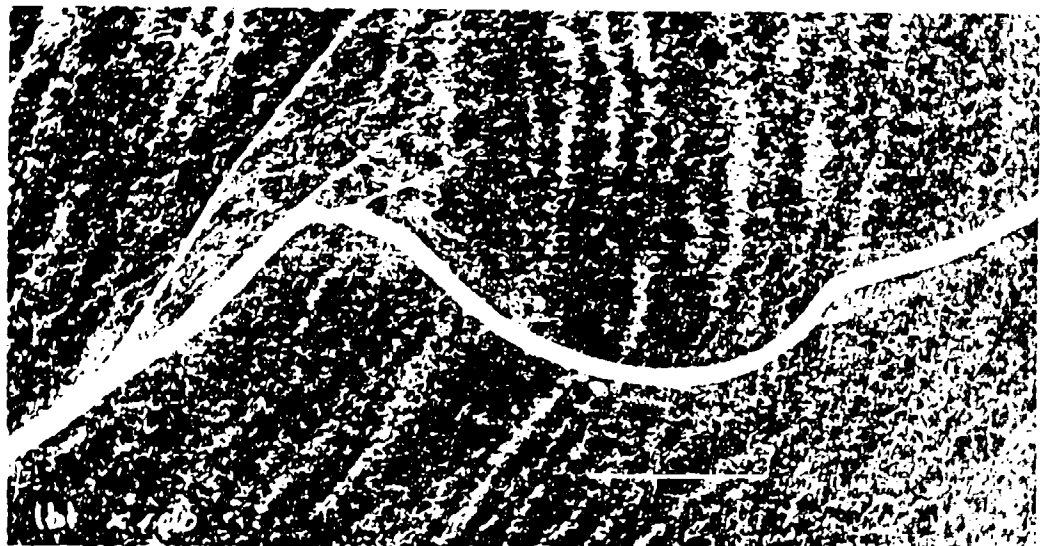
FIG 10

Normal etching reveals clearly the movement or faulting of the metal near the bullet hole but, on the other hand, fails to reveal the internal structure of the "white layer", as shown in Figure 10 (a), (b) and (c). The abrupt shift in the banding continuity from one side of the "white layer" to the other in Figures 10 (a) and (b), shows distinct evidence of a sudden slipping of the metal in the plane through the layer. The degree of this deformation is evident when it is considered that in the undistorted region beyond the bullet hole, the banding is perpendicular to the direction

- (c) In this case the layer seems to be the boundary of an angular deflection of the banding, rather than the place of a linear shift in their continuity. The "density" of these bandings also appears different on each side, showing a kind of compression of the banding on the side nearest the bullet hole. 1% Nital, #Ex 26-Round 5 MA 175

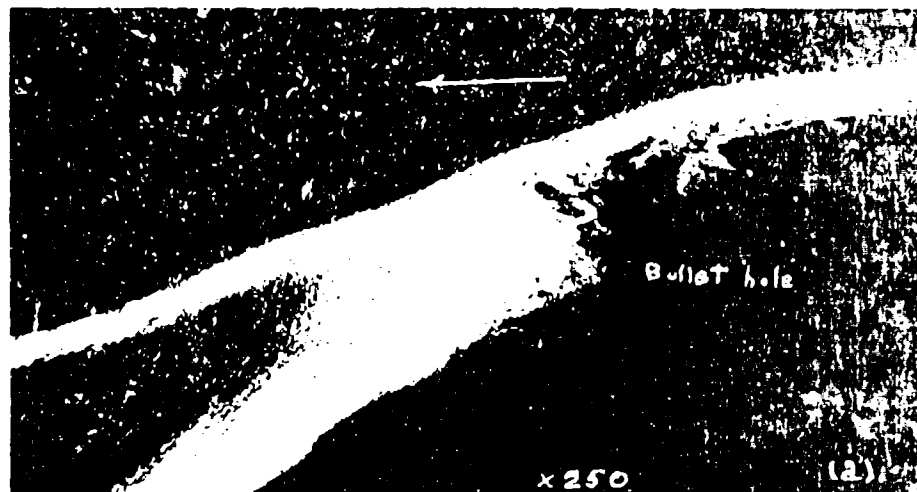
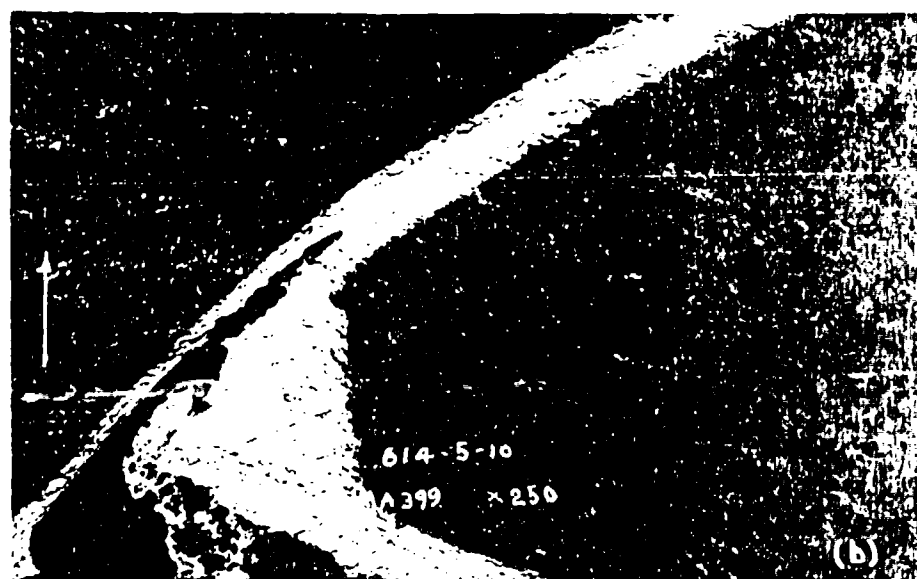
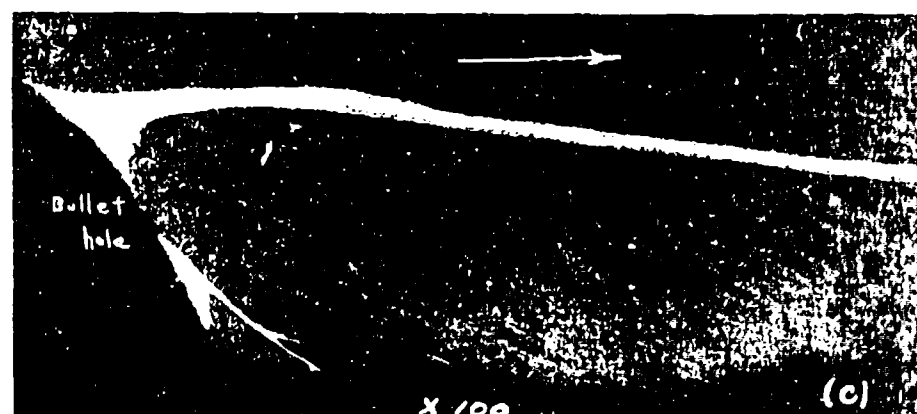
FIG. 11

- (a) Illustrating the sort of fine "flow" lines found at the outer edges of many of the broader layers. Here they branch into a relatively thick layer which forms a coating on the bullet hole, where they become more pronounced. A coating like this, which shows the "flow lines so plainly in all cases, etches much more readily than layers in the interior of the metal, regardless of whether "flow" lines are found or not.

- (b) Etching to the extent shown in this micrograph, which brings out a set of "flow" lines to a considerable depth into the layer, was rarely found on a lightly etched and untempered specimen. The layer is also unusually broad.

- (c) Layer which runs quite parallel to the bullet hole. Notice here also the "coring" effect caused by the partial etching of the borders while the center remains unetched.

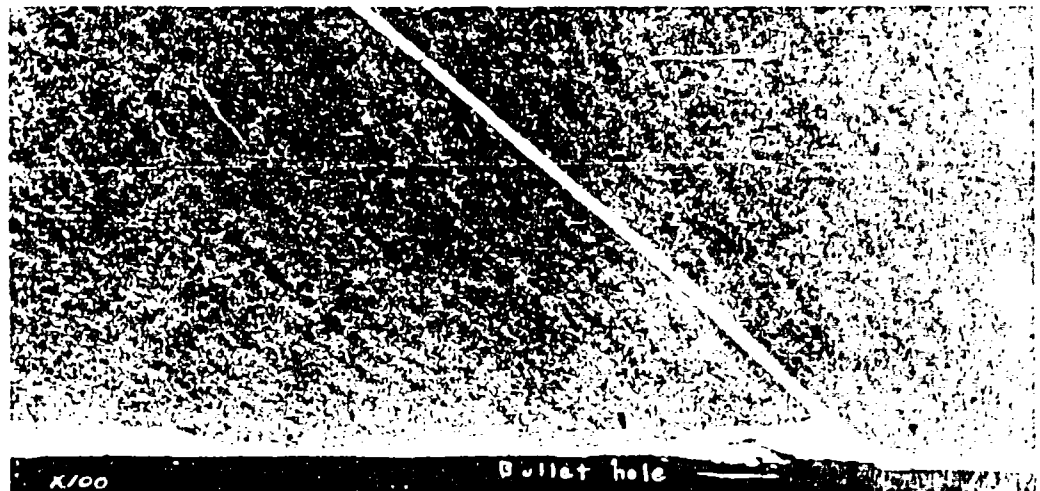
FIG 12

- (b) Coring effect at edge of "white layer". This coring effect is probably caused by tempering of the martensitic "white layer" as the result of heat from bullet impact, thus producing troostitic borders.

- (d) This "white layer" which terminates in the vicinity of much slag, does not seem to have any relation to it.

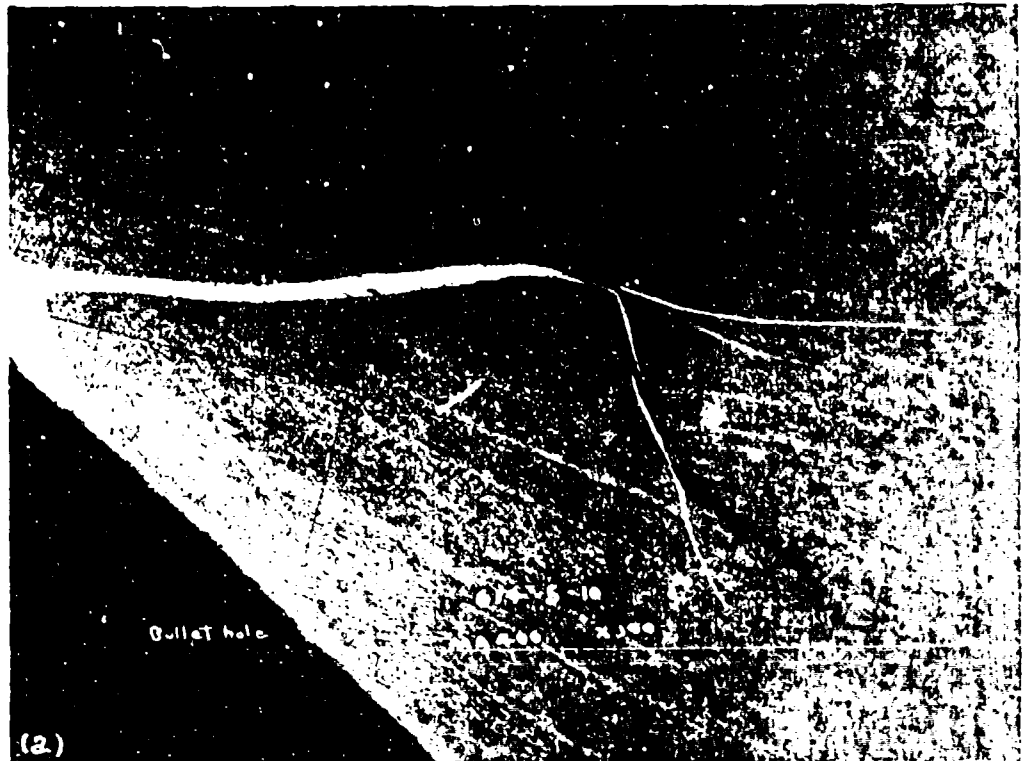
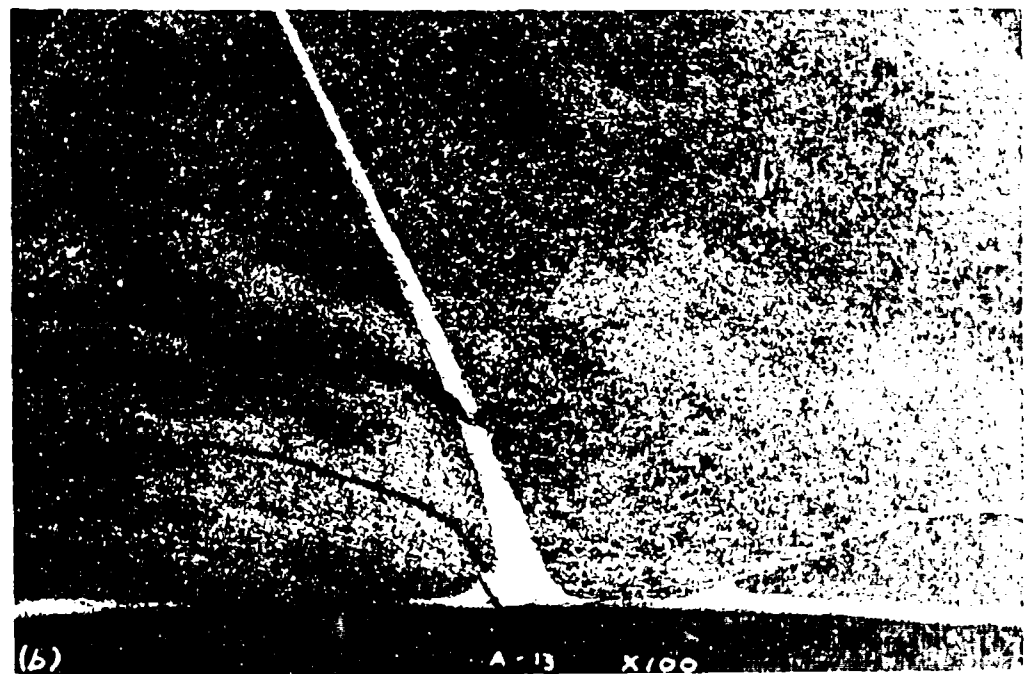
FIG 13

- (a) An interesting concurrence of crack and "white layer", although no inference can be drawn as to any inter-relation of the two.

- (b) This shows an abrupt shift in the crack's continuity at the boundary of the "white layer", indicating either a slipping of this whole layer after the formation of the crack, or a slipping of the metal after the crack's formation that was part of the process of layer formation.

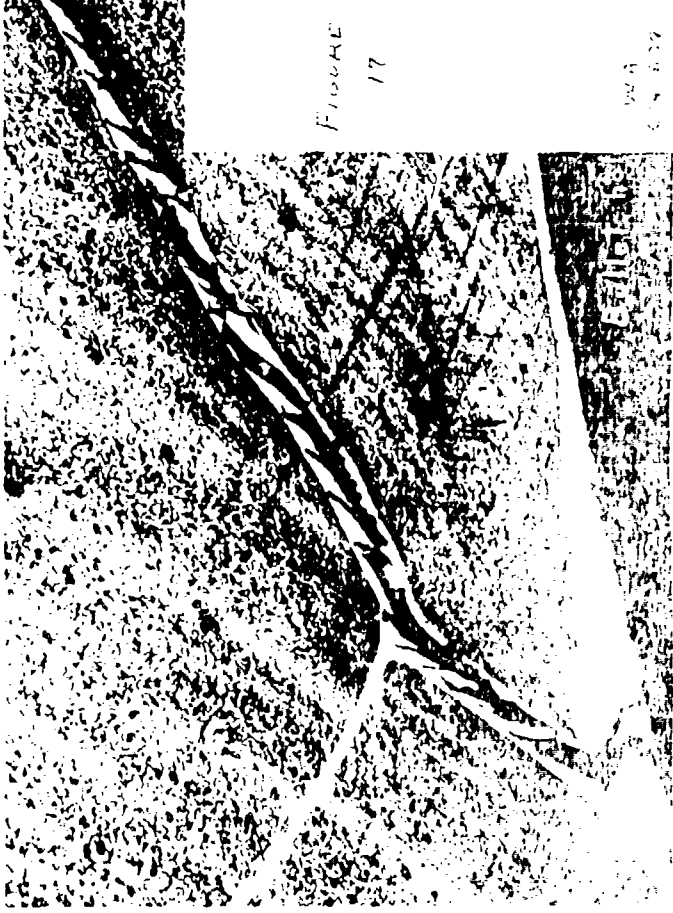
FIGURE
17

Illustrating in different steels, and at various magnifications, the twisting jagged crack characteristic of a large proportion of cracks in "white layers".

- (a) This micrograph is not so clear because of the very deep etch, but it shows the twisting of crack and "white layer" at high power.

- (b) Notice the termination of the cracking at the extreme upper part of the picture. On visual examination of the rest of the "white layer" it was found to be entirely free of cracks from this point on.

It is believed that this evidence of twist in the crack systems is the result of torsional impact. The twists in "white layers" were found near the bottom and close to the side of the bullet hole. Together with the information obtained from macro study, these pictures support the view that the spin of the bullet has exercised a torsional force on the metal.

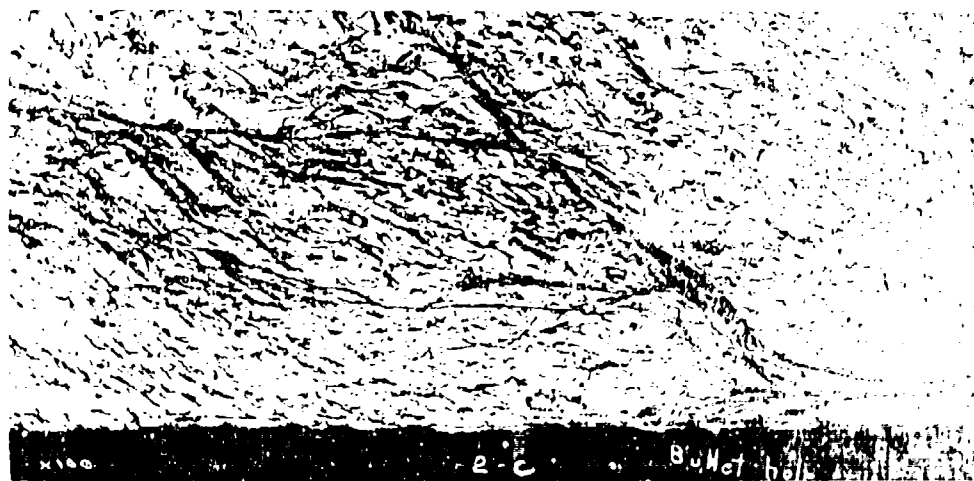
FIGURE 21.

- (a), (b), (c), (d), These all show a characteristic blackening about the bullet hole which is a carbide precipitation caused by heat effect of the penetrating bullet.

- (f) Microstructure of plate in an area far removed from the penetration.

- (i) Carbides found in selected areas as well as grain boundaries.

The structure of the manganese steel plate at considerable distance away from the bullet penetrations consists of a normal austenitic grain with no evidence of carbides at the grain boundaries, Figure 21 (f).
